# A STUDY OF BIBLINS FOOTBRIDGE

# I D Molesworth<sup>1</sup>

Student - University of Bath

**Abstract**: This report is a detailed study of Biblins Footbridge. The bridge is an aesthetically appealing footbridge situated over the river Wye near the town of Ross on Wye on the western fringe of the Forest of Dean. The report analyses the aesthetics, loading, construction, strength, serviceability and future requirements of the bridge, with emphasis on the central suspension span.

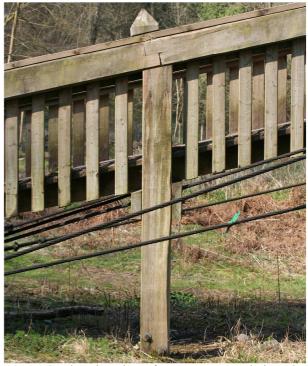
The bridge, while well detailed in places is not particularly refined. Small aesthetic details have been applied to certain parts of the bridge (see Fig. 3) however these are either unnecessary or badly detailed. The pinnacles shown in Fig. 3 and 4 are an example of this. Provided to suggest the vertical supports for the ramps protruded through the handrail, the pinnacles have been inaccurately positioned so as to not be perfectly in-line with the columns. Secondly the handrail also protrudes wider than the columns and it is obvious there is no continuity between pinnacle and column (Fig. 4). The areas that are well resolved are generally the areas where the detailing has simply been left as the required construction, which, for a bridge where the description of the form is plain to see, is the most fitting treatment.

Figure 3: Elevation view of ramp support and pinnacle.

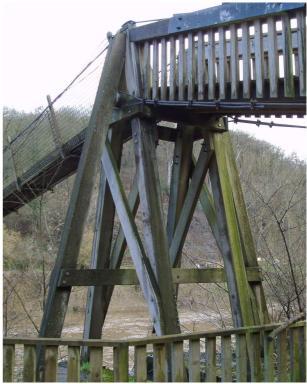
The towers and approach ramps are constructed from locally sourced oak timbers and are 'A' frame shape in elevation. The joints are simple bolted connections. Metal saddle bearings are provided where the cables pass over the tower from the abutments to the central span. Resistance to lateral loads is provided by two large oak members, as can be seen in Fig. 7. Figure 7 also shows the cross bracing in the tower, this bracing is different to that of the original construction, and was changed when the towers were refurbished in 1997. The original cross bracing can be seen in Fig. 9 showing the extra level of bracing that was provided in the original design.

Figure 7: Tower construction, showing lateral bracing

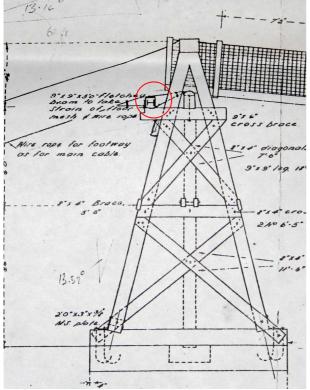
As far as can be gauged the bridge was originally designed to carry loading both through the main cables via the wooden hangers and through the mesh of the deck. This theory is supported by the above paragraph, where the majority of lateral restraint could be provided by the deck if it is also being held under tension. The mesh was originally designed to attach to a fletched steel I beam to which more cables also attached carrying the load to ground (Fig. 9). The cables fixed directly to the steel, with the mesh being carried by the wooden fletching

Figure 9: Original drawing showing tower and fletched beam (circled). [1]

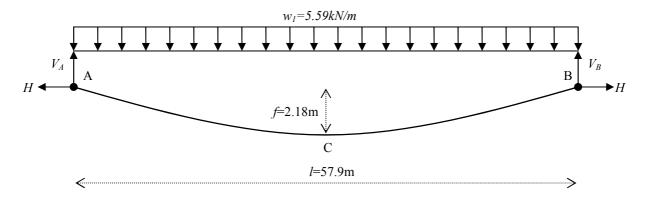
Figure 14: Diagram of assumed structure for calculations.

The stress in the cable is very high, suggesting that the bridge was designed for a much lower design load, this is likely as the bridge was designed in 1957, and today's design codes will not necessarily apply. For this reason the following calculations consider a lower live loading. The calculations make the same assumptions as the above calculation and use the same diagram as Fig. 14, with  $w_1$  replaced by  $w_2$ , which is calculated below.

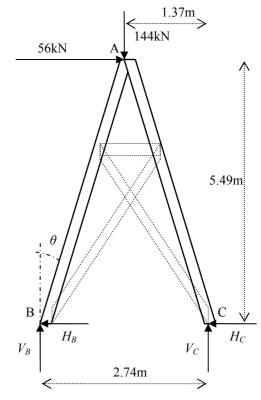
Figure 15: Diagram of loading on tower.

For these calculations it can be assumed that the tower legs are pin-jointed, with each other and the footings. Secondly assume the cross bracing serves as a means to prevent buckling rather than carrying direct load from the cable saddle to ground. Hence the major load carrying members are AB and AC, and the analysis will treat these as such. Theta ( $\theta$ ) is the angle between the legs and the vertical.
